**RE: Consent Decree (Case: No. 1:12-cv-24400-FAM),
Reference DOJ Case No. 90-5-1-1-4022/1,
Section IX – Reporting Requirements, Paragraph 32 – Quarterly Reports – 2015
Quarterly Report No. 1**

2015 Quarterly Report No. 1

Quarterly Report of Sanitary Sewer Overflows (SSOs)

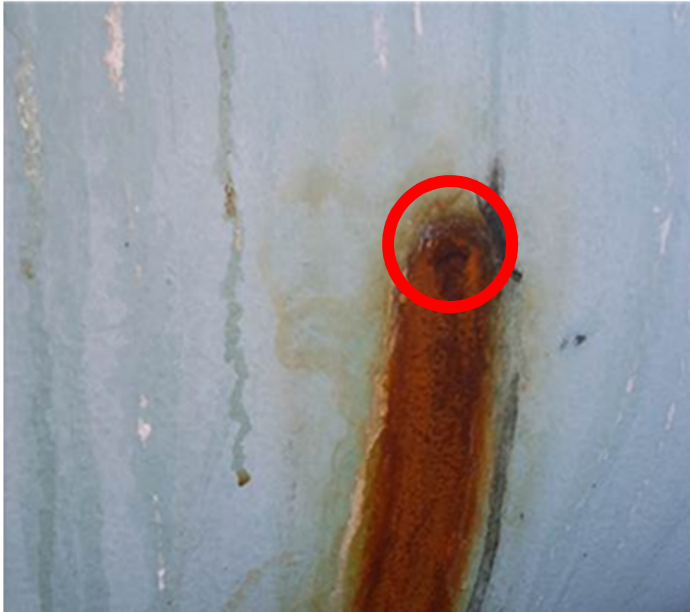
Figure 3 - Damage to 24" DIP

28-Feb-15	4:00 PM	65 NE 202nd Ter	FM	4:50	5,800	Snake Creek Canal	Yes	24" DIP force main leakage due to vandalism ²	Installed clamp on pipe	yes	Force main recommended for replacement
02-Mar-15	1:00 PM	21350 SW 114 Ave	GM	0:35	10	Storm Drain	No	Gravity main blockage due to grease	Cleared gravity main grease blockage and notified local regulatory agency (RER-DERM)	No	No further action required
06-Mar-15	9:50 AM	11259 SW 88 St	GM	0:35	5	Land	No	Gravity main blockage due to grease	Cleared gravity main grease blockage and notified local regulatory agency (RER-DERM)	No	No further action required
7-Mar-15	1:30 PM	25324 SW 128 Pl	GM	1:30	10	Land	No	Gravity main blockage due to debris	Cleared gravity main blockage	No	No further action required
9-Mar-15	2:50 PM	890 SW 84 Ave	GM	1:00	25	Land	No	Gravity main blockage due to grease	Cleared gravity main blockage and notified local regulatory agency (RER-DERM)	No	No further action required

The pictures below depict a circular puncture to the external wall of the 24" DIP presumably caused by a bullet. However, the bullet could not be recovered. The crew repaired the damage by installing a clamp.
